**ELMWOOD ESTATES AND ARROWWOOD ESTATES
FLOOD MITIGATION REPORT**

BROKEN ARROW, OKLAHOMA

JULY 2017

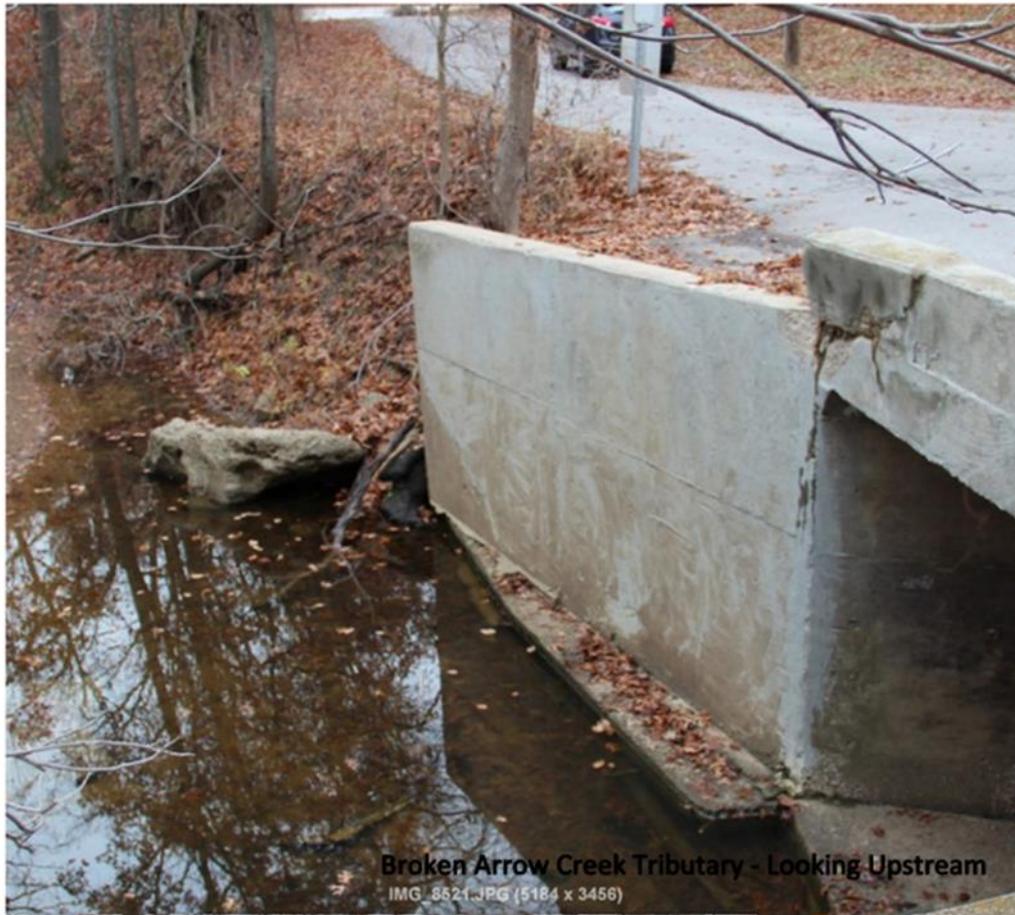
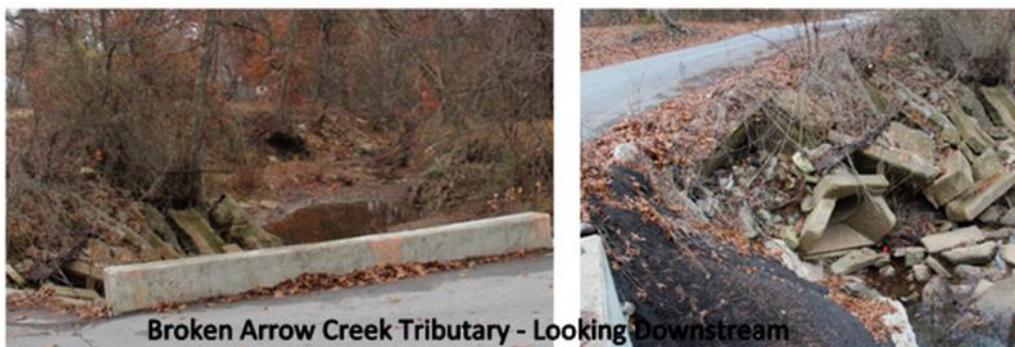
Both these locations are in Arrowwood Estates and their comments mention the erosion of stream banks on the Broken Arrow Creek Tributary at East 114th Street South crossing. The creek flows southwest to the culvert and has to make a ninety degree turn to go through the culvert. This structure is located close to the intersection of East 114th Street South and South 199th East Avenue. There is some major erosion on the sides of South 199th East Avenue where a cross drain is provided to drain the area to the west of this road. The water that

discharges on the west side of South 199th East Avenue has caused erosion at this location. The photographs below show the streambank erosion near this intersection.

Upstream and downstream of East 114th Street in Broken Arrow Creek Tributary, the channel needs to be cleaned up to clear it from all the debris and provide some erosion control measures. The easiest and simplest solution for erosion control is to protect the toe, develop a floodplain bench and tie a moderate slope back to the natural grade. Riprap would be placed at the existing toe and if necessary the bank would be tied back at 2:1 slope or to a point stable vegetation can be established. The rock toe would prevent undermining of the banks during low flows and the vegetative cover provides protection from moderate flows. This method would require greater construction easements for excavating the slope back and can be applied only where the channel can be widened.

Another method that can be utilized, where there is limited space to widen the floodplain is, gabion walls. These walls can provide a near vertical bank slope. If the vertical walls are installed at the existing toe of the bank, the conveyance area can be reduced which may adversely impact the water surface elevation. Another option is to use shorter vertical gabion wall with a bench established at the top and then the remaining slope would tie back to the existing ground using 3:1 vegetated and maintainable slopes. Gabion walls can also be done stair stepped facing the creek.

Since most of the erosion mentioned in this area are in the backyards or near the streets there is not much room to widen the channel. Hence, gabion walls are a practical erosion control option to consider for these areas. Any erosion control measures analyzed here need detailed field investigation and geotechnical analysis before designing it, therefore no cost estimate is included.

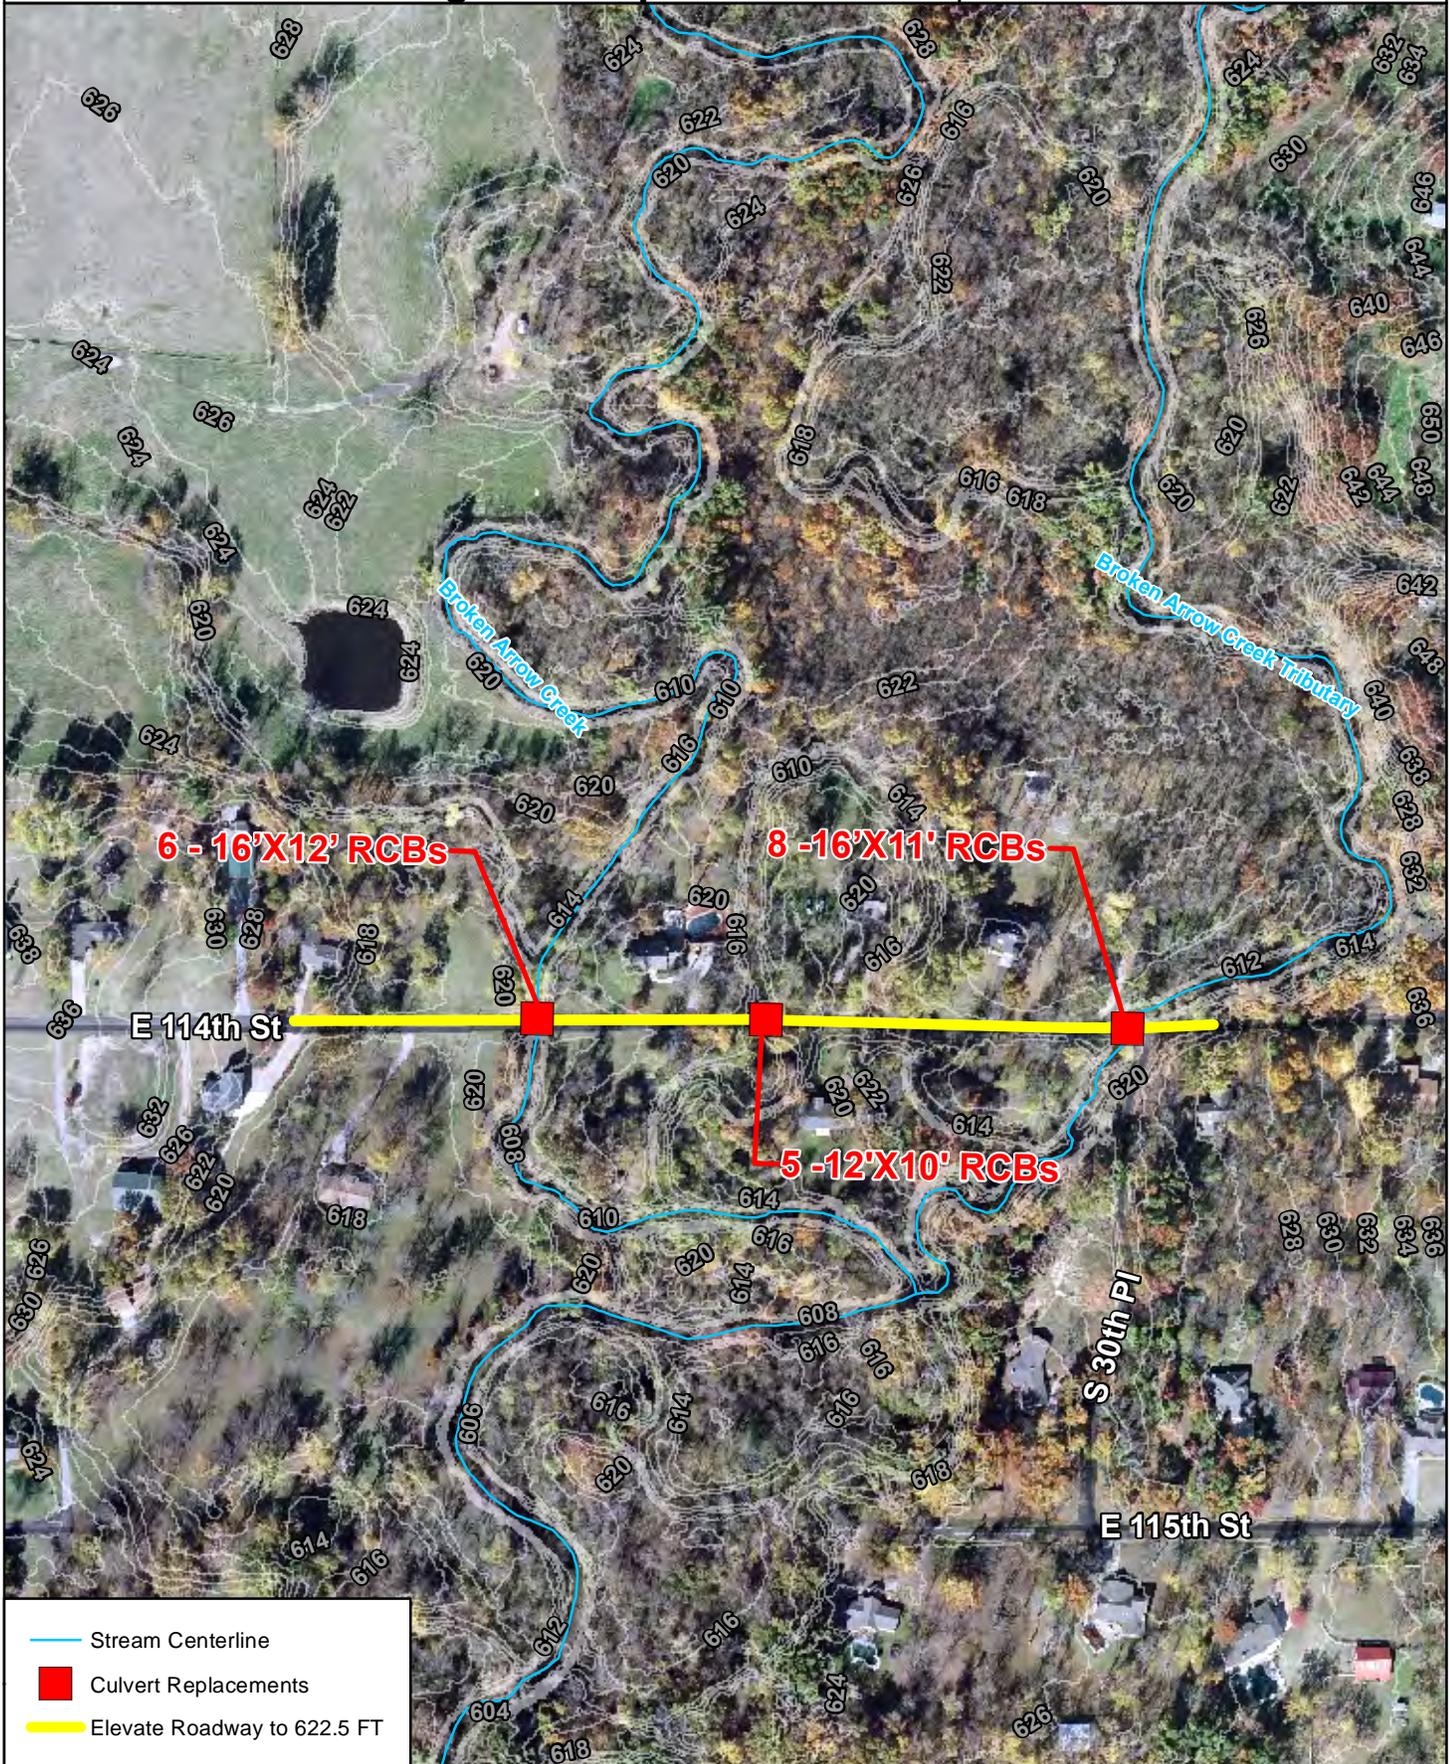
**Figure
2 - 4**

Problem Area 1 is located in Arrowwood Estates subdivision. Arrowwood Estates is at the confluence of Broken Arrow Creek Tributary with the Mainstem. Houses are built along the sides of East 114th Street and East 115th Street and these roads are connected with South 199th East Avenue. In existing condition, the 1% Annual Chance (100-year) storm peak flow rate at the confluence is approximately 9015 cfs. The peak flow rate from Broken Arrow Creek Tributary near this confluence is 6798 cfs and the mainstem has a peak flow of 3640 cfs.

East 114th Street serves as the only access road to all houses in Arrowwood Estates. This street crosses both the Broken Arrow Creek mainstem and its tributary. In existing conditions, this road overtops from storm events as low as 50% Annual Chance (2-year) storm and blocks the access to several houses in this subdivision. The existing structure on Broken Arrow Creek mainstem is a 12'X8' RCB and on Broken Arrow Creek Tributary a 11'X6.5' RCB. There is significant bank erosion near these culverts. Also, there is a 30" RCP between these two boxes. Six properties on this street are built within a 100-year floodplain and of which 2 properties are repetitive loss structures per the Federal Emergency Management Agency (FEMA) insurance claim data.

Alternative 1: Acquire 6 houses + Improve East 114th Street to have 1% Annual Chance Storm (100-year) Capacity.

This alternative analyzed an option that includes acquiring 6 houses located in the 100-year floodplain near the confluence of the Broken Arrow Creek mainstem and Broken Arrow Creek Tributary along with elevating the road and improving the structures under the road to have a 100-year capacity. In existing conditions, this road starts to overtop for frequencies less than 2-year. Since the roadway is very low and there is significant tailwater downstream of the road, the only way to improve the capacity of the roadway is to elevate the road and enlarge the culverts. In existing conditions, the lowest elevation on the road is 615 feet and the 2-year and 100-year water surface elevations at the road are 617.54 feet and 622.37 feet, respectively. To achieve a 100-year capacity for the structures under this road, the road needs to be elevated to a minimum elevation of 622.5 feet and it involves approximately 1210 feet long roadway section. This roadway improvement will also require some improvements on South 199th East Avenue, the road that connects East 114th Street and East 115th Street. The existing single 12'X8' RCB under Broken Arrow Creek mainstem should be replaced with 6 – 16'X12' RCBs. The existing single 11'X6.5' RCB under Broken Arrow Creek Tributary replaced with 8-16'X11' RCBs. The existing 30" RCP between the creeks with 5-12'X10' RCBs. Since this alternative does not cause any significant reduction in the water surface elevation, the property acquisition is included to eliminate the risk of flooding to the properties within the floodplain. Approximate finish floor elevations were estimated for these properties from the existing contour and analyzing the photographs. All those houses are built at or below an elevation of 620.5 feet and will have a flood water depth of 1- foot or more during a 100-year event. The houses on the south side of East 114th Street flood from a 10-year storm event. The roadway and culvert upgrade improves the vehicular (both residential and emergency) access to the remaining properties in Arrowwood estates. This alternative is shown in **FIGURE 2-4**. The cost for this alternative is estimated at \$4,535,900 and is detailed in **APPENDIX C-1**. Including the cost to acquire the 6 houses would add an additional \$1,280,110 making the total cost estimate for this alternative approximately \$5,816,010.

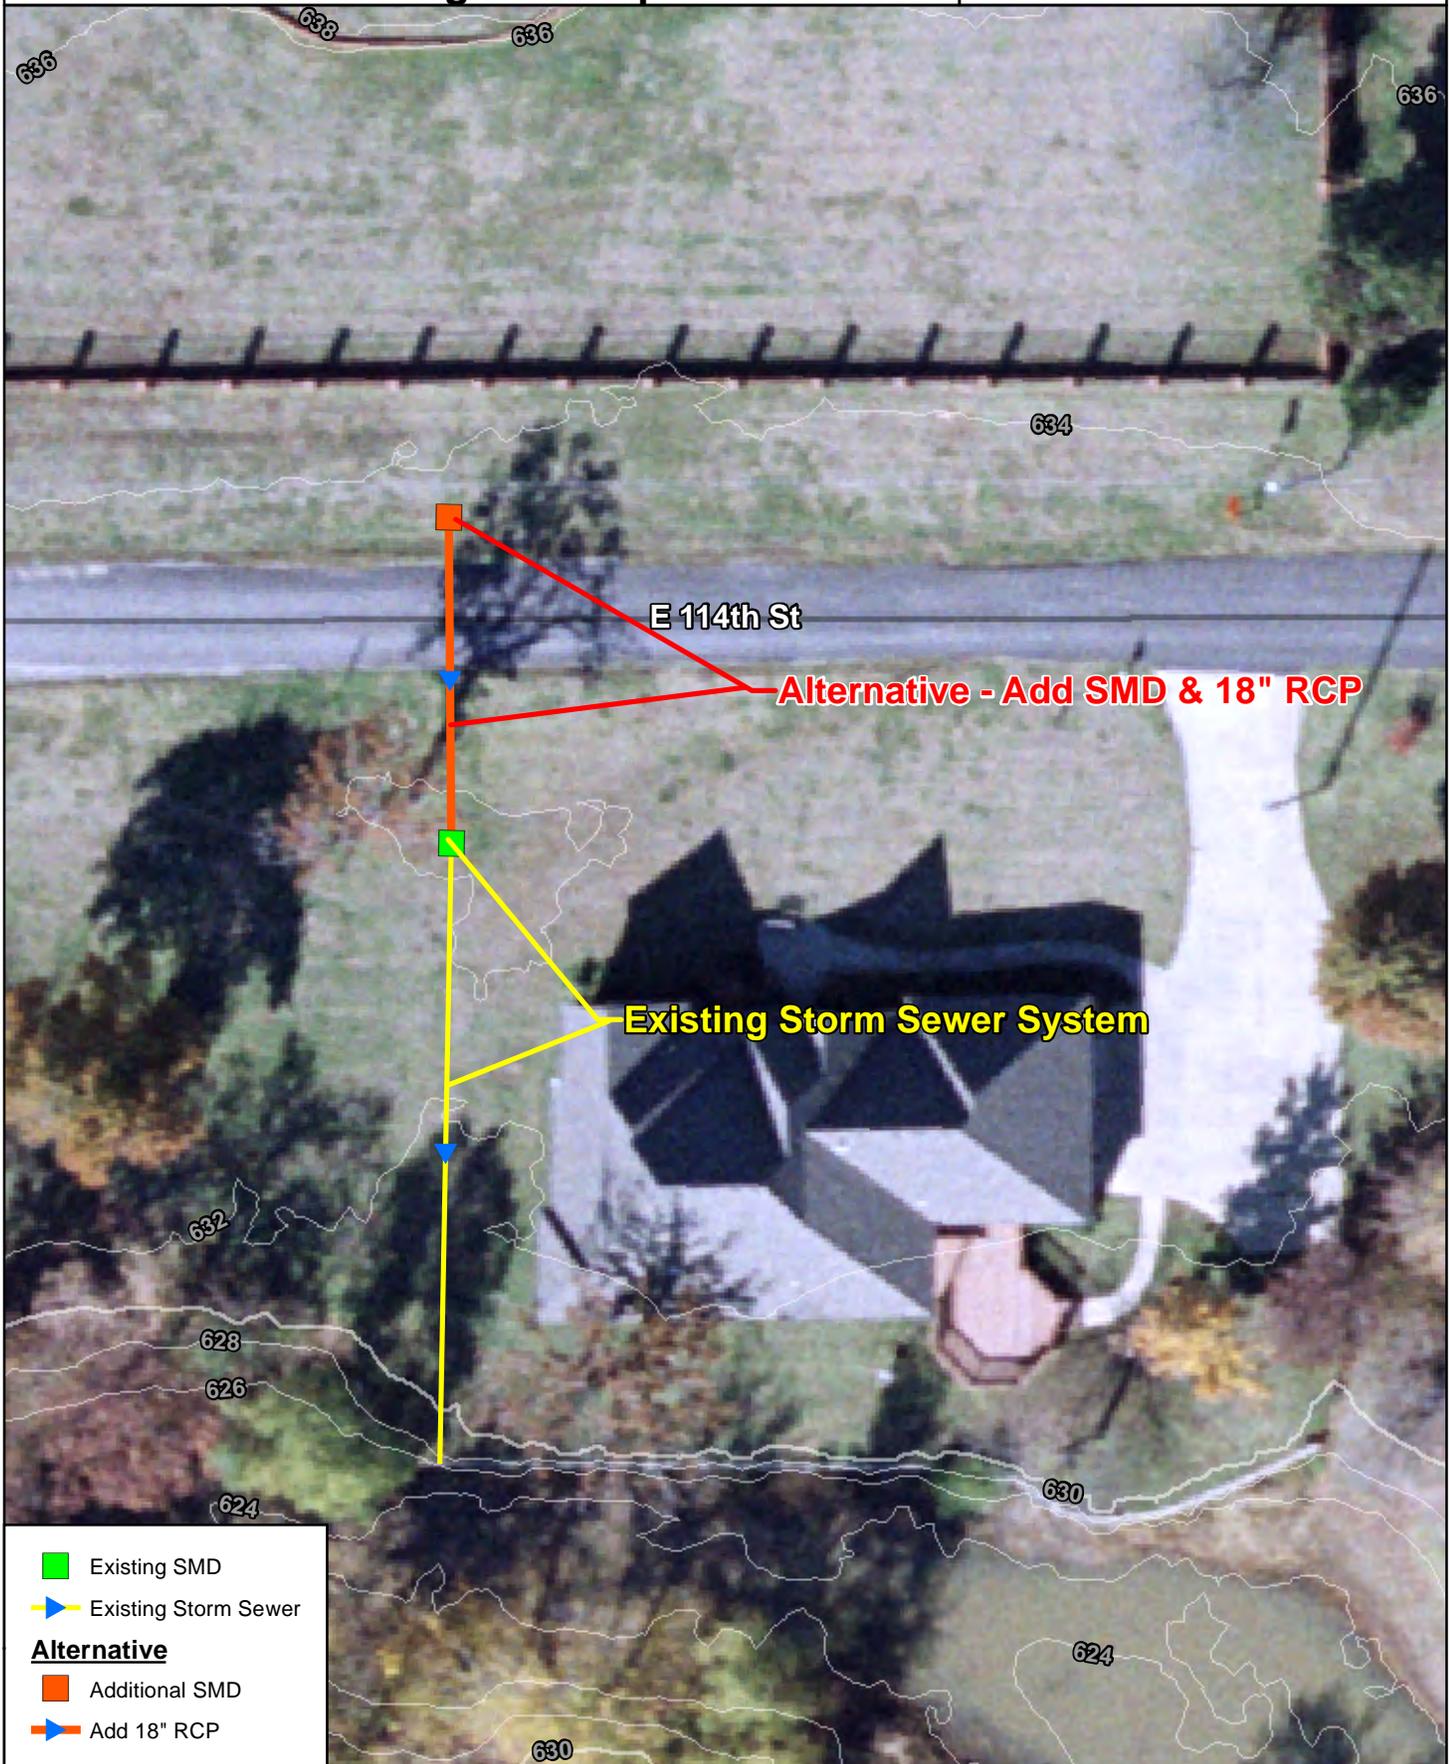
This location is outside of the 100-year floodplain of Broken Arrow Creek and is a localized drainage issue in Arrowwood Estates. There is a 10" steel pipe that crosses 114th Street, near the entrance of Arrowwood Estates, that drains to the front yard of this property. The yard is graded to flow west and then drain south into the creek behind the house. During heavy rain, the pipe gets clogged and water starts to pond on the north side of the road and eventually overtops the road. This causes a nuisance situation in the yards and the road as well as deteriorates the road.

From the existing condition analysis, approximately 2.6 acres of area drains to this location. The property owner has a SMD Drain and swale system through the west side of their property. This alternative assumes an SMD with an 18" cross drain that would connect to the existing SMD on the property owner's yard and then drain to the creek through the existing storm sewer. This alternative also includes some grading on the north side of East 114th Street to drain water in the direction of proposed SMD. This proposed alternative is shown in **FIGURE 2-12** below. The cost for this alternative is estimated at \$16,400 and is detailed in **APPENDIX C-9**.

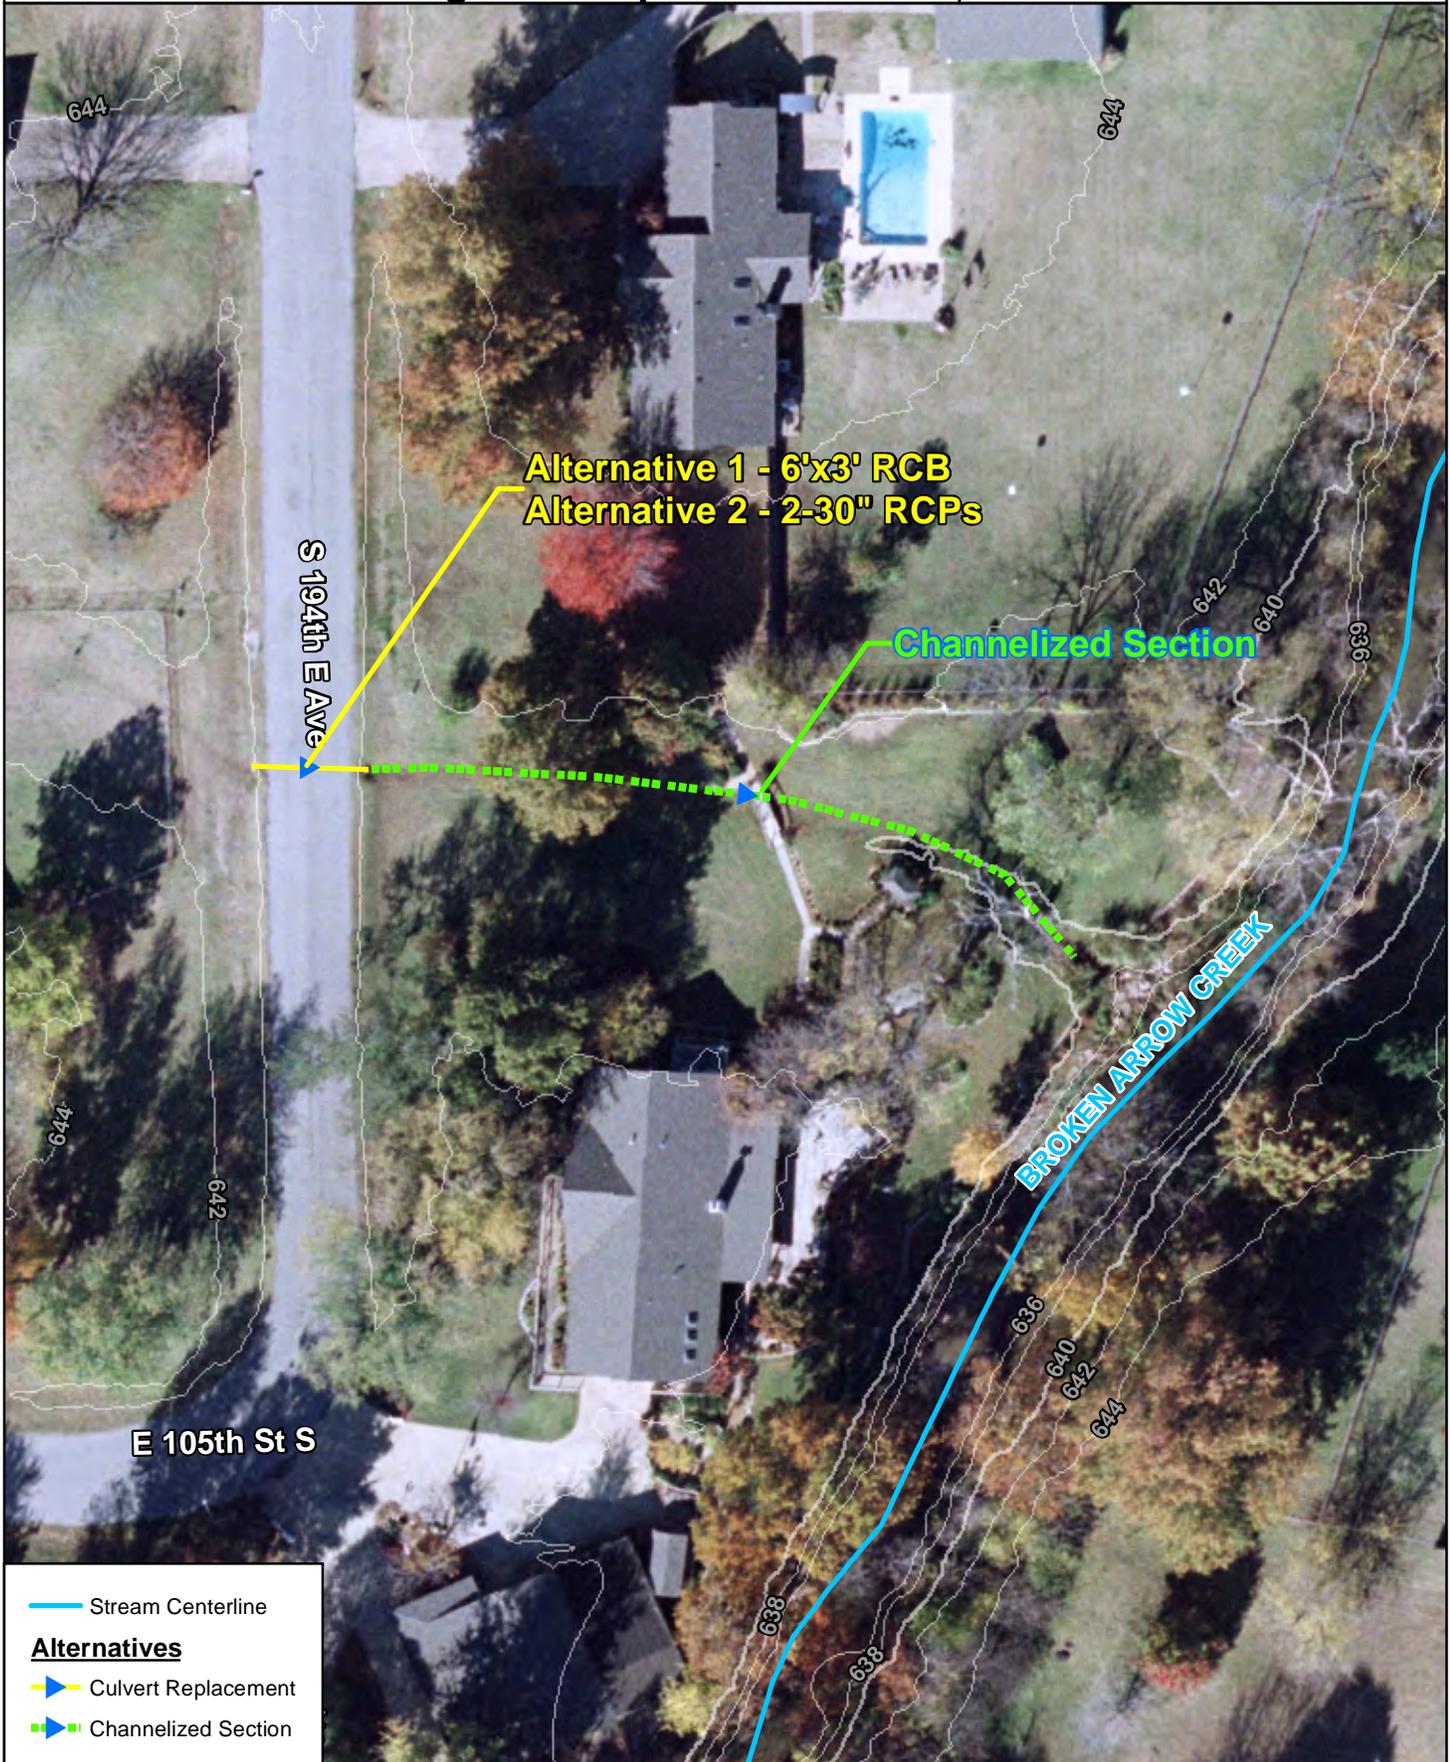
**Figure
2 - 13**

This location is in the Elmwood Estates subdivision and is located on the east side of South 194th East Avenue near its intersection with East 105th Street South. There is a 24" RCP that drains across South 194th East Avenue and discharges into the north side of this property. This pipe drains approximately 17 acres. The downstream side of this pipe is not graded properly to

allow the water flow into Broken Arrow Creek. The water ponds near the downstream side of this pipe and floods the yard.

In existing conditions, this pipe under 194th East Avenue drains approximately 17 acres and the 100-year peak flow rate at this location is approximately 108 cfs. This entire area is within the 100-year floodplain of Broken Arrow Creek mainstem. The existing ground elevation is 642 feet near the existing pipe and 640 feet near the creek. The 10-year water surface elevation in Broken Arrow Creek mainstem at this location is 642.72 feet.

Alternative 1 - A grass lined trapezoidal channel with a bottom width of 2 feet and 4:1 side slopes can be graded through the north side of the yard to convey the 100-year discharge to the creek. The existing 24" RCP under South 194th East Avenue needs to be replaced with a 6'X3' RCB to eliminate water ponding on the west side of this street. This proposed channel will have a top width of 22 feet and a water depth of 2.5 feet. With an assumed channel slope of 0.5%, the channel velocity is 3.6 fps. The cost for this alternative is \$171,000 and is detailed in **APPENDIX C-10**.

Alternative 2 - The 10-year peak flow at this location is approximately 65 cfs. A 10-year alternative would require replacing the existing 24" RCP under South 194th East Avenue with double 30" RCPs and a grass lined trapezoidal channel with a 2-foot bottom width and 4:1 side slopes to carry the water to Broken Arrow Creek mainstem. This proposed 10-year channel has a top width of 18 feet and water depth of 2 feet. The channel velocity is 3 fps. The cost for this alternative is estimated at \$84,100 and is detailed in **APPENDIX C-11**. Proposed culverts and channel alignment for both Alternative 1 and Alternative 2 are shown in **FIGURE 2-13**.

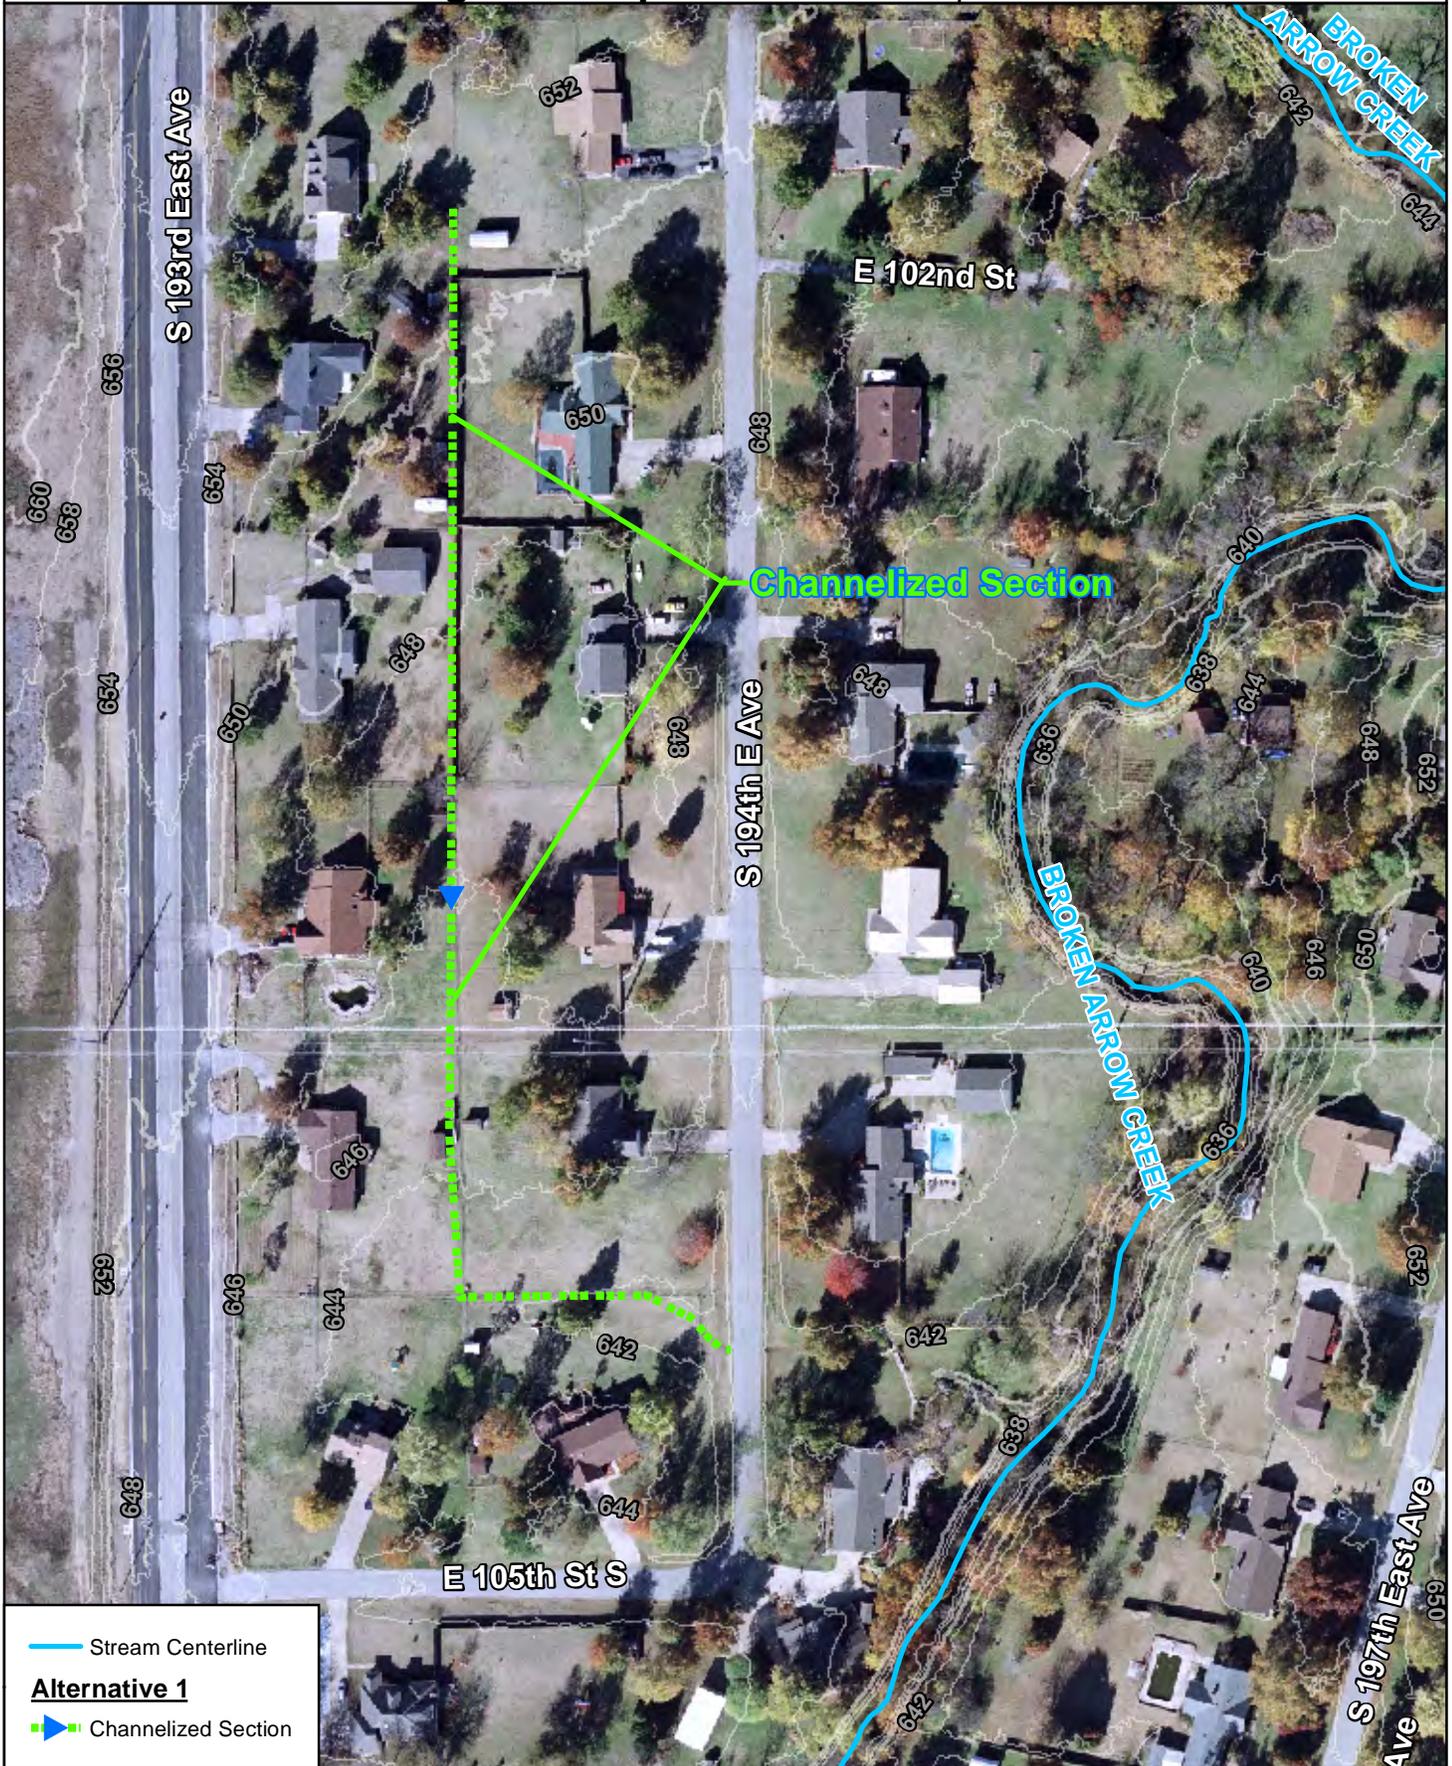
**Figure
2 - 14**

This location is in the Elmwood Estates subdivision and is located on the east side of South 193rd East Avenue. There has been water in the garage during flood events as well as a lot of water in the back yard. Per the contour data from 2011, most of the houses between South 193rd East Avenue and South 194th East Avenue have their backyards draining south. This flow then turns southeast right at the backyard of this property before it gets into the 24" RCP under South 194th East Avenue. Approximately 8 acres of land drain to this location.

This house is lower than E. 193rd East Avenue and the drive way slopes down to the garage. Water from the road does not appear to drain into the property. The roadway is curbed with storm sewer that drains to the Broken Arrow Creek mainstem. A slotted drain across the driveway can help to collect the water running down the driveway before it reaches the garage. If this water collected from the drive way and the water in the ponding area can be connected to the existing storm sewer system, it should help to alleviate the flooding issues on the front side of this property.

The backyard is the recipient of flow from several lots to the north. A swale could be graded through the backyards to convey the water to the cross drain proposed in Problem Area 6. To convey the 100-year event, approximately 40 cfs, a trapezoidal channel with a 2-foot bottom width and 4:1 side slopes could convey the water with an average water depth of 1.7 feet and velocity of 2.8 fps to the culvert under South 194th East Avenue. All of this area is private property and there are no drainage easements. The cost for this alternative is estimated at \$163,500 and is detailed in **APPENDIX C-12**. This proposed channel alignment is shown in **FIGURE 2-14**.
