**ELMWOOD ESTATES AND ARROWWOOD ESTATES
FLOOD MITIGATION REPORT**

BROKEN ARROW, OKLAHOMA

JULY 2017

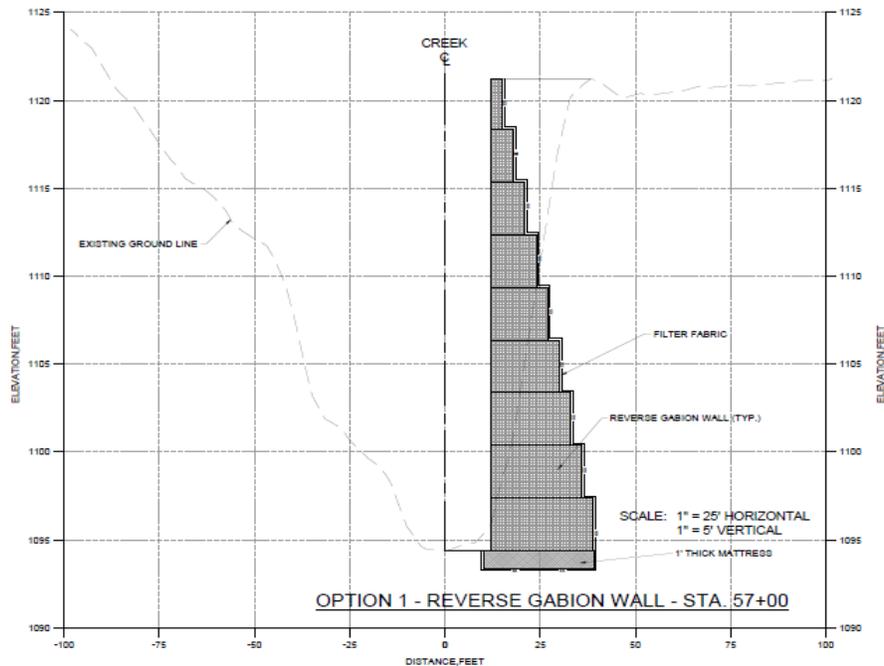
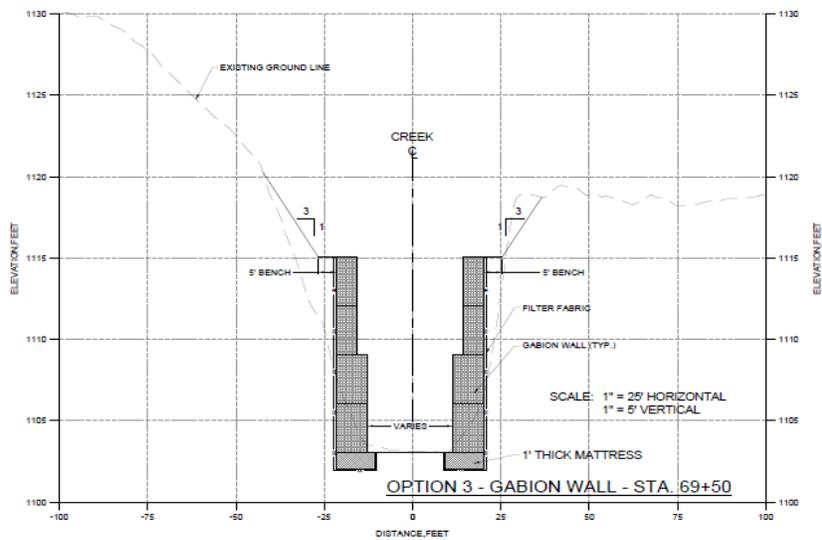
Upstream and downstream of East 114th Street in Broken Arrow Creek Tributary, the channel needs to be cleaned up to clear it from all the debris and provide some erosion control measures. The easiest and simplest solution for erosion control is to protect the toe, develop a floodplain bench and tie a moderate slope back to the natural grade. Riprap would be placed at the existing toe and if necessary the bank would be tied back at 2:1 slope or to a point stable vegetation can be established. The rock toe would prevent undermining of the banks during low flows and the vegetative cover provides protection from moderate flows. This method would require greater construction easements for excavating the slope back and can be applied only where the channel can be widened.

Since most of the erosion mentioned in this area are in the backyards or near the streets there is not much room to widen the channel. Hence, gabion walls are a practical erosion control option to consider for these areas. Any erosion control measures analyzed here need detailed field investigation and geotechnical analysis before designing it, therefore no cost estimate is included.

Another method that can be utilized, where there is limited space to widen the floodplain is, gabion walls. These walls can provide a near vertical bank slope. If the vertical walls are installed at the existing toe of the bank, the conveyance area can be reduced which may adversely impact the water surface elevation. Another option is to use shorter vertical gabion wall with a bench established at the top and then the remaining slope would tie back to the existing ground using 3:1 vegetated and maintainable slopes. Gabion walls can also be done stair stepped facing the creek.
